1902 BUILDING - NORTHWEST VIEW

ST. MARK UNITED METHODIST CHURCH
1902 BLDG. EXTERIOR MAINTENANCE
W&A: 21-01169-100-01, CMJ, 3/3/23

1902 BUILDING - NORTHEAST VIEW

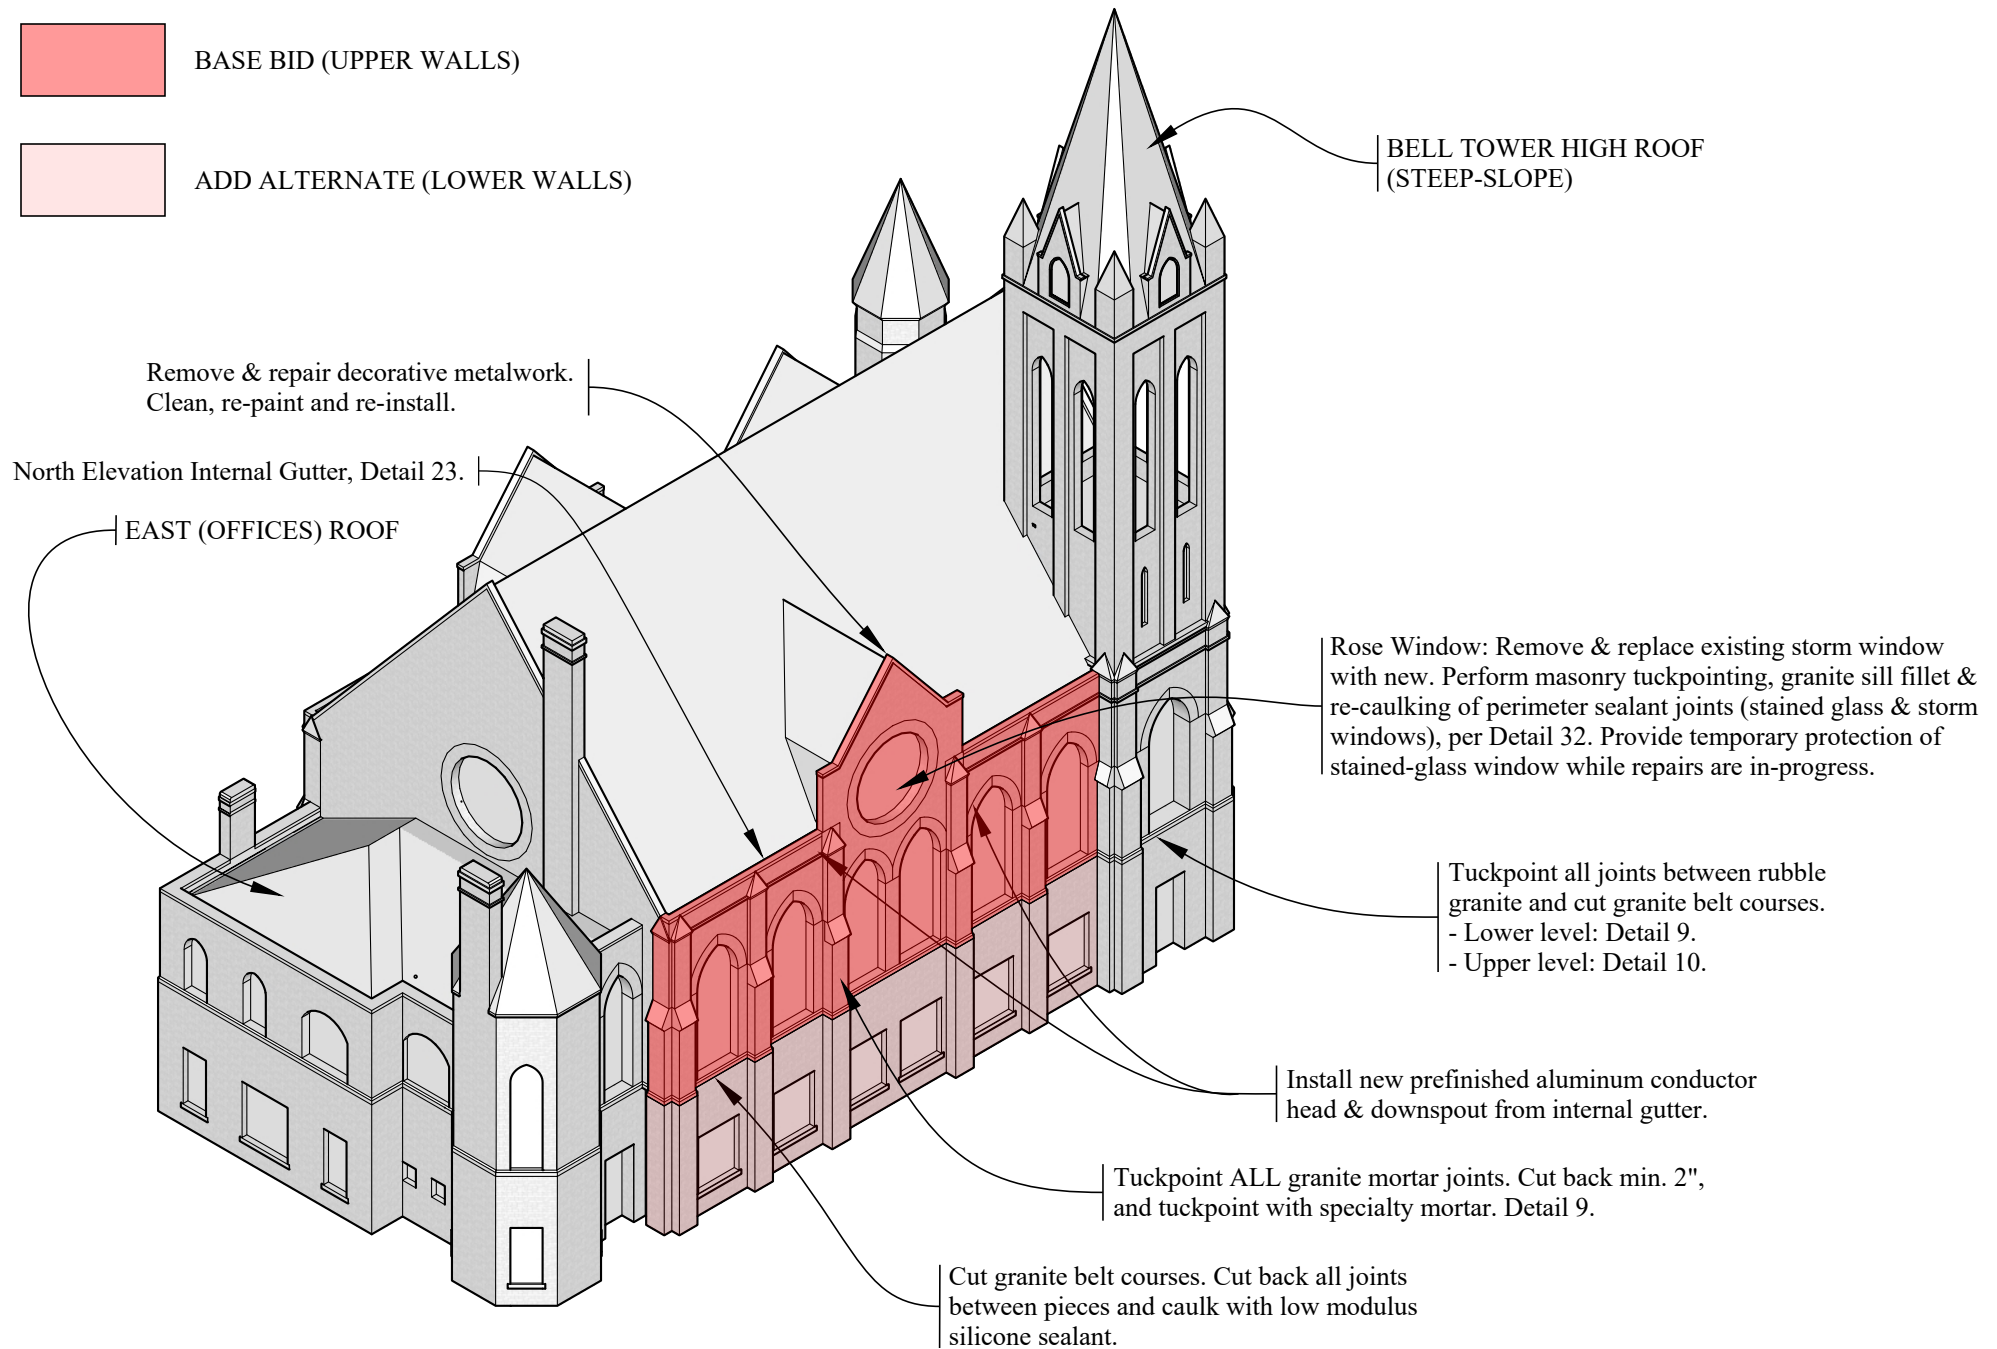
3
W&A

BASE BID (UPPER WALLS)

ADD ALTERNATE (LOWER WALLS)
